date: DECEMBER 1975."

AIRFIELD PAVEMENT CONDITION SURVEY, USNAS MIRAMAR, CALIFORNIA

Technical Memorandum M-75-53-2

R. B. Brownie

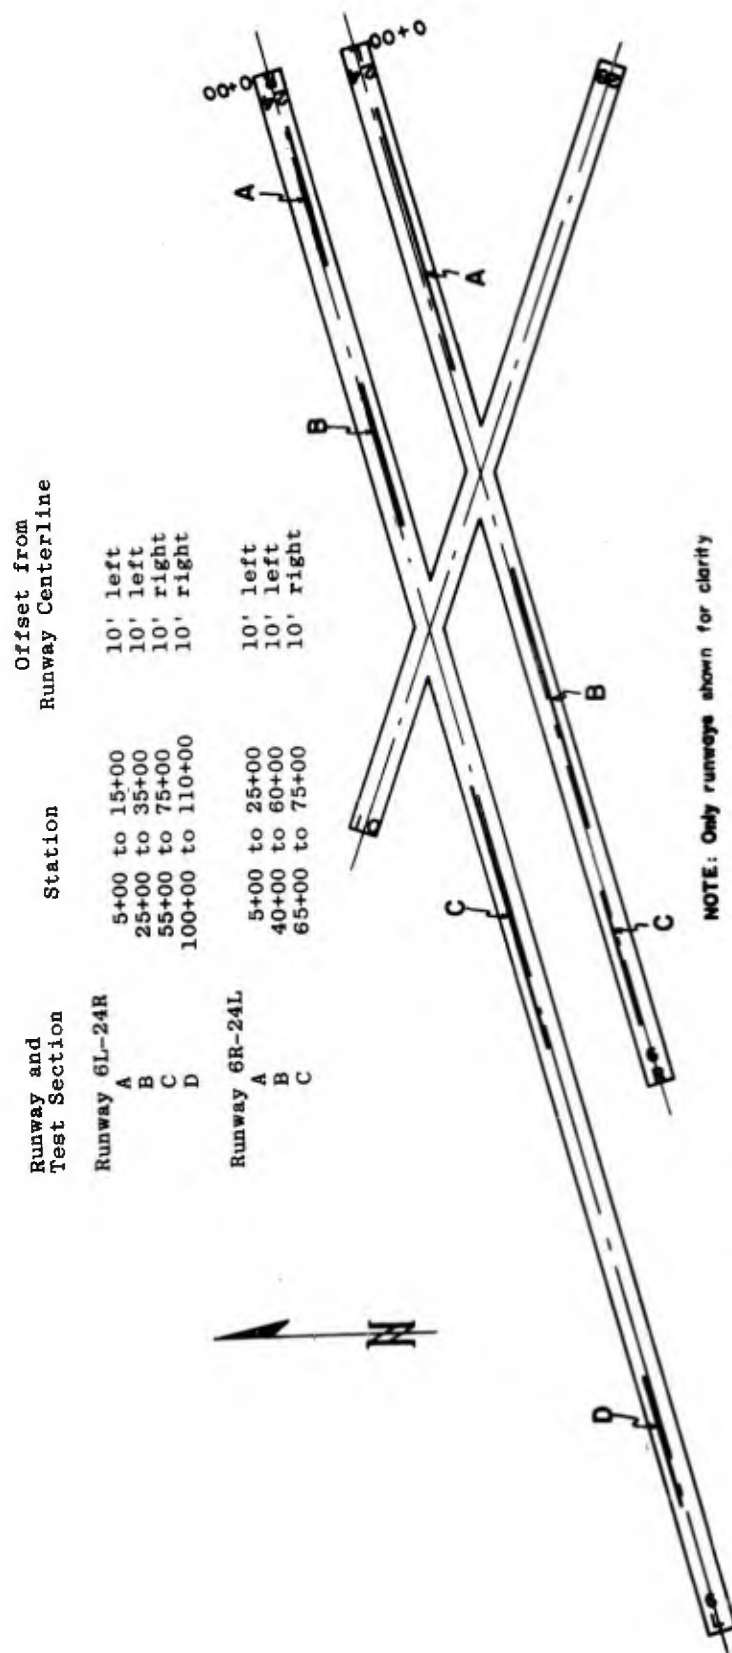
FIGURE 14

Test sections on each runway were selected to provide a representative sample of the skid resistance properties of each runway. The test section layout is shown in Figure 14. The test sections were selected to provide pavement friction data in: (a) the aircraft touchdown areas, and (b) the runway interior where maximum braking is normally developed. No friction tests were made on Runway 10-28 as it is used only for arrested landings.

FRICITION TEST LOCATIONS
USNAS MIRAMAR, CALIF.

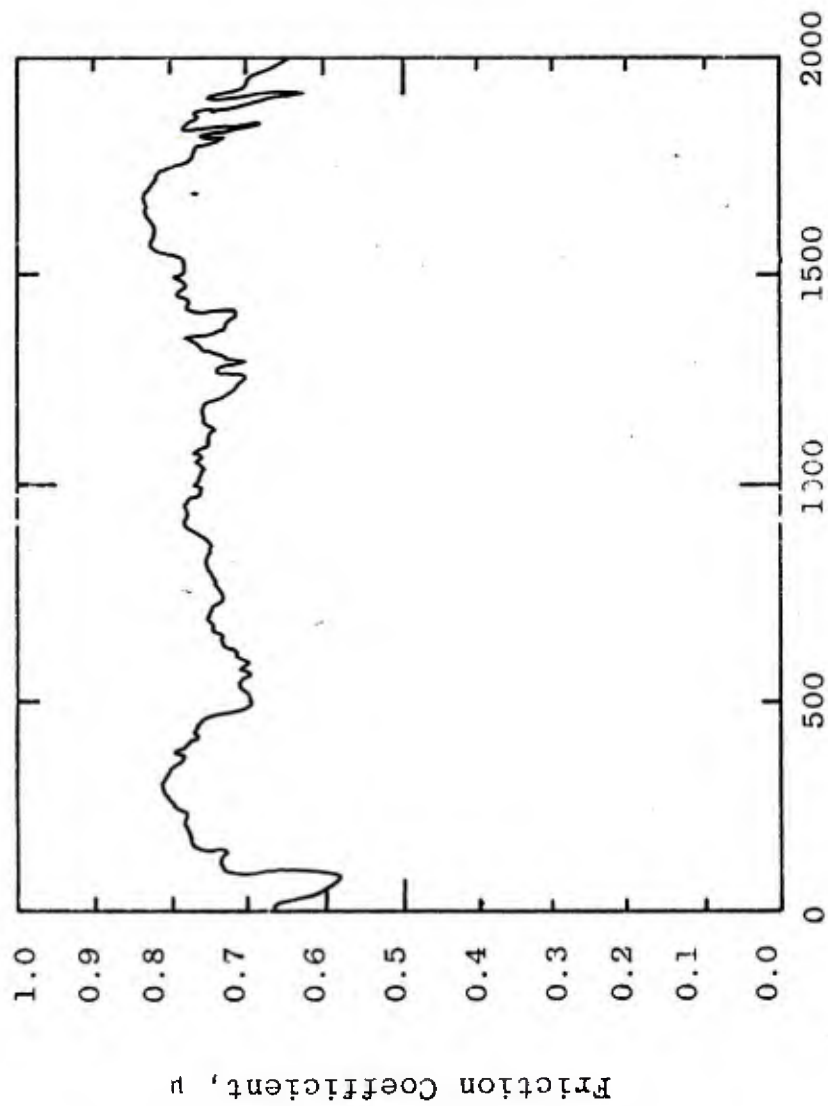
Figure 15. Friction Coefficient versus Distance,
USNAS Miramar, California

Distance, feet
Runway 6R-24L
Test Section A, Run 1
USNAS Miramar, California

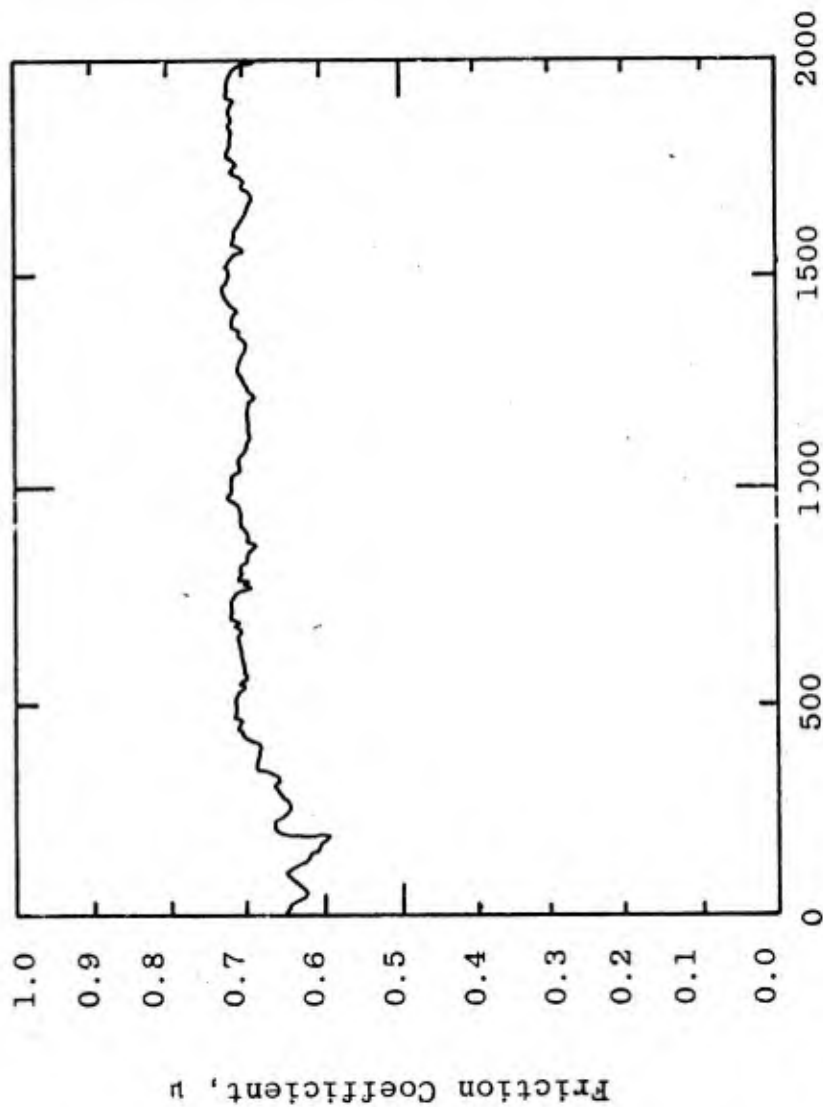
Figure 16. Friction Coefficient versus Distance,
USNAS Miramar, California

Distance, feet
Runway 6R-24L
Test Section B, Run 1

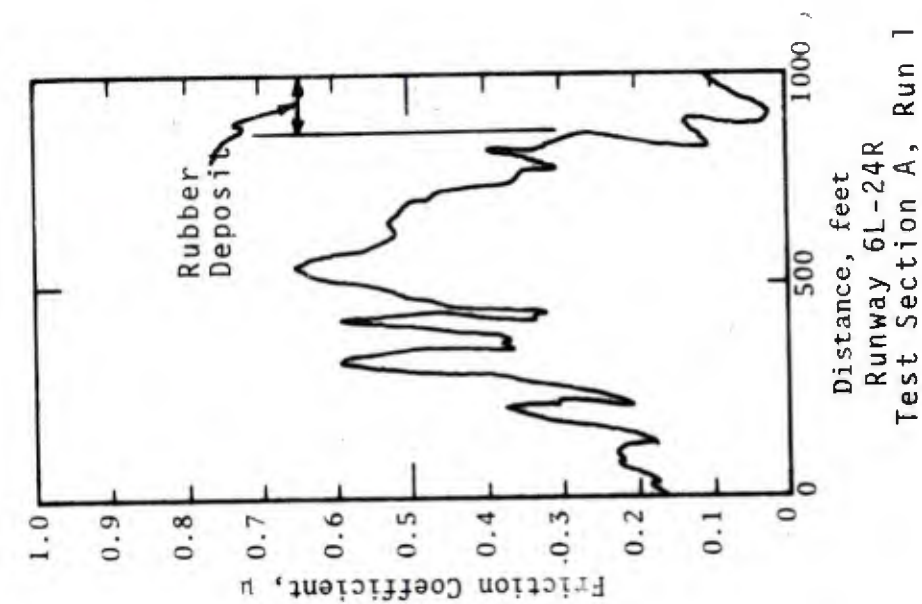
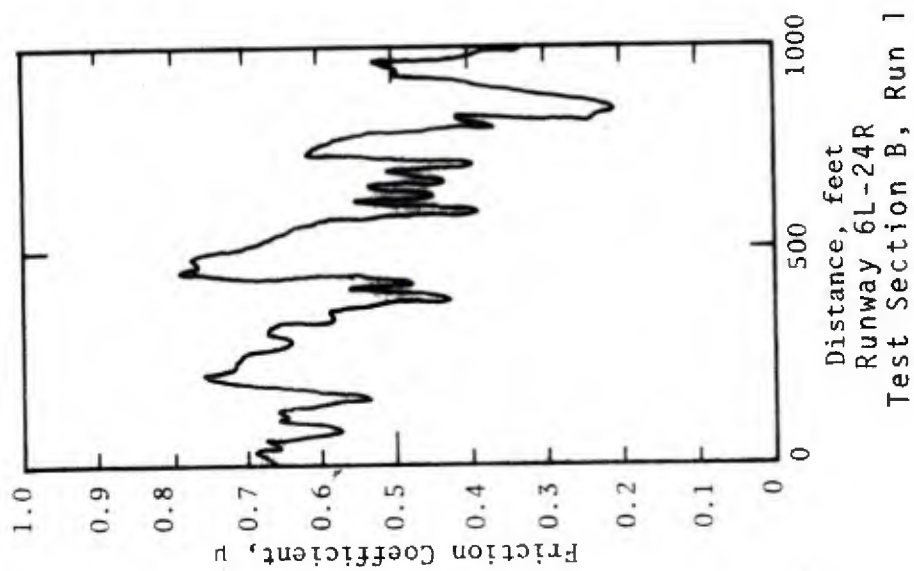
Figure 18. Friction Coefficient versus Distance, USNAS Miramar, California

covered area of Runway 6L-24R as shown in Figure 18. It is also assumed that the FCLP (field carrier landing practice) area on Runway 6R-24L would have similar properties. The FCLP area was not included in the friction test sections as it is located on the side of the runway out of normal aircraft braking areas.

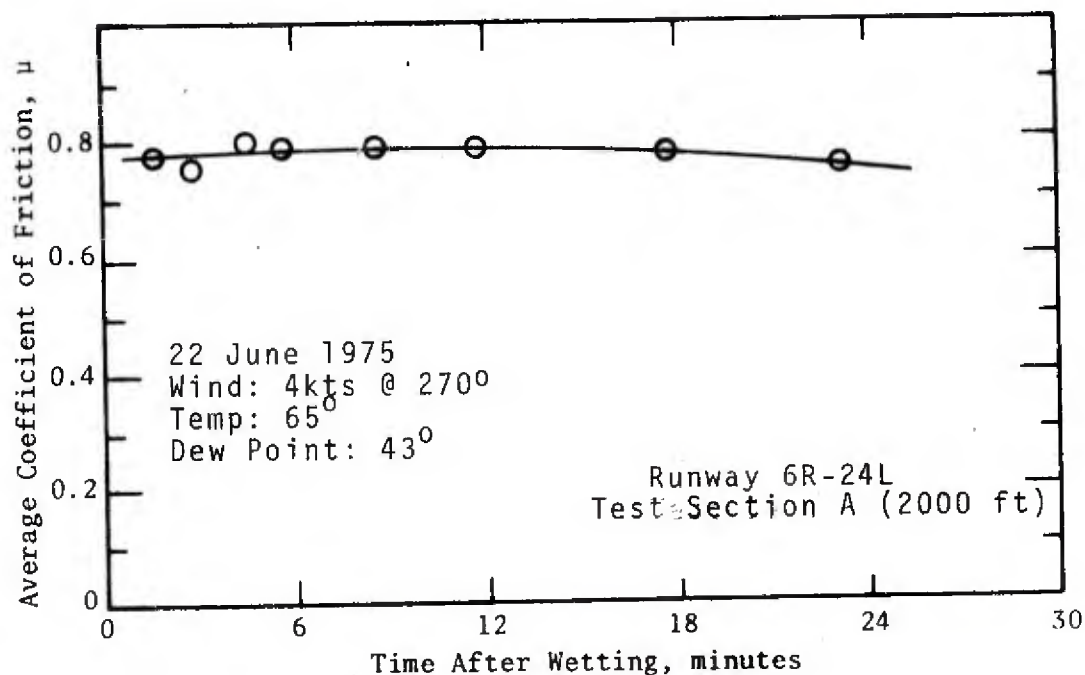
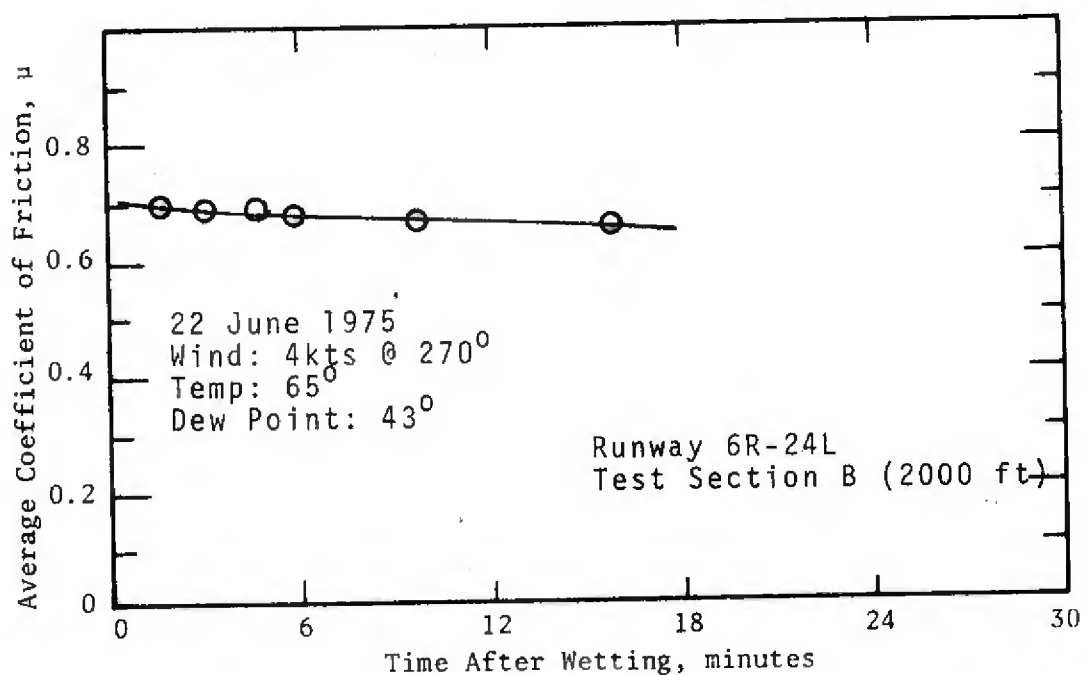
Figure 21. Average Friction Coefficient Versus Time After Wetting, USNAS Miramar, California

Figures 21 through 24 show changes in surface friction coefficient versus time after wetting for each pavement section tested. (Note that the time intervals after wetting at which skid tests were made often differed from one test to another, due to small variations in water truck speed and Mu-Meter adjustments). These graphs demonstrate the natural drainage characteristics of the runway surface and the time required to return to an essentially dry condition or a consistently high friction coefficient.
